# Stormwater Compliance

# Case Scenario

## 84 Acre Land Development

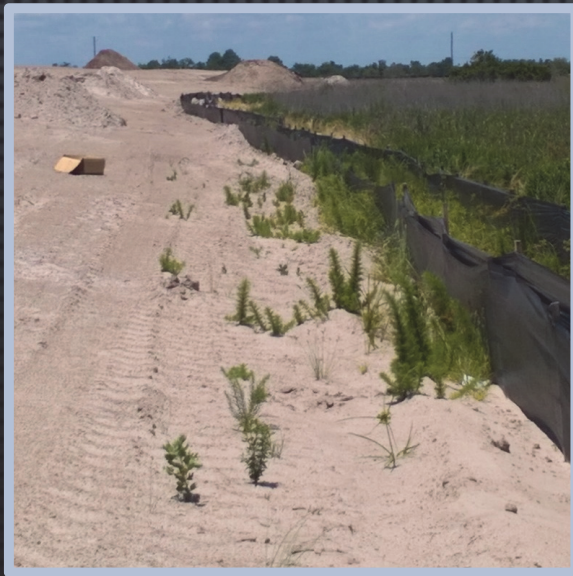
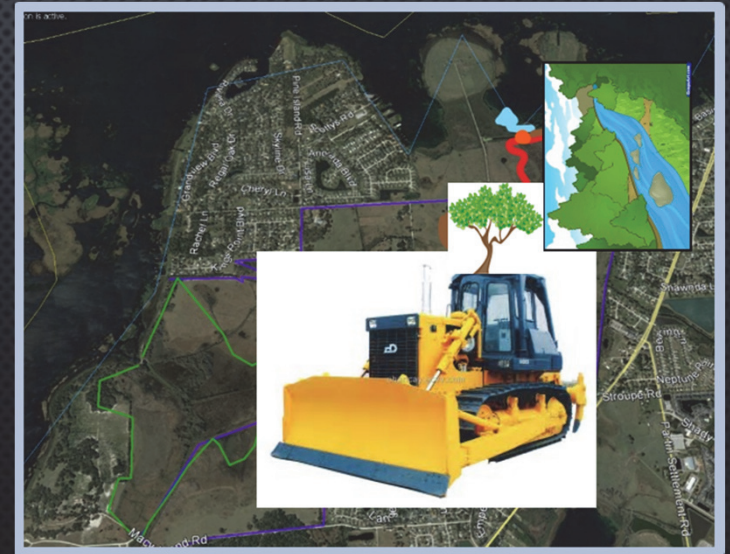
- Large Construction Land Development
  - Surrounded by wetlands → discharge to a Ranch Land → pump to Lake.
- Newly constructed ponds not complete

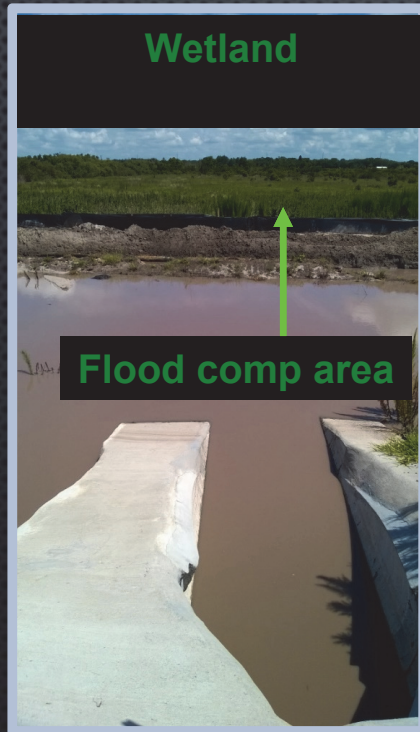
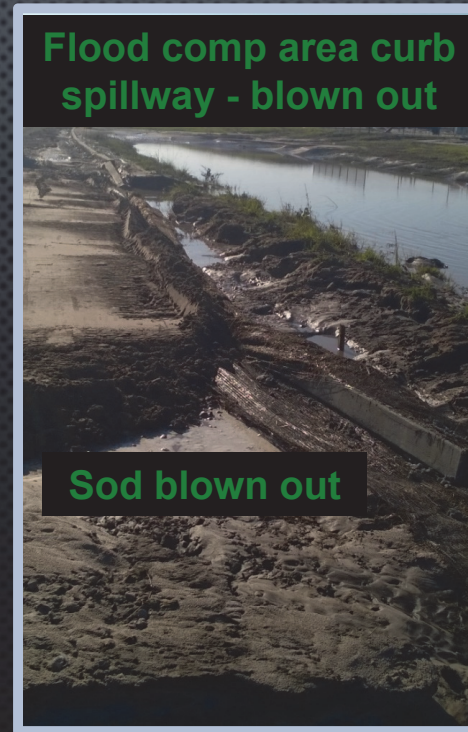
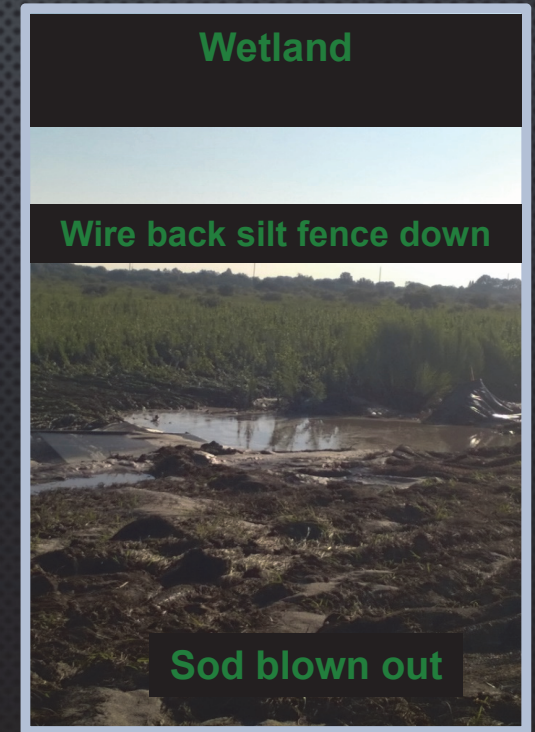
# After the storm...Overnight July 17<sup>th</sup>

- Six inches of rain
- Flash flooding

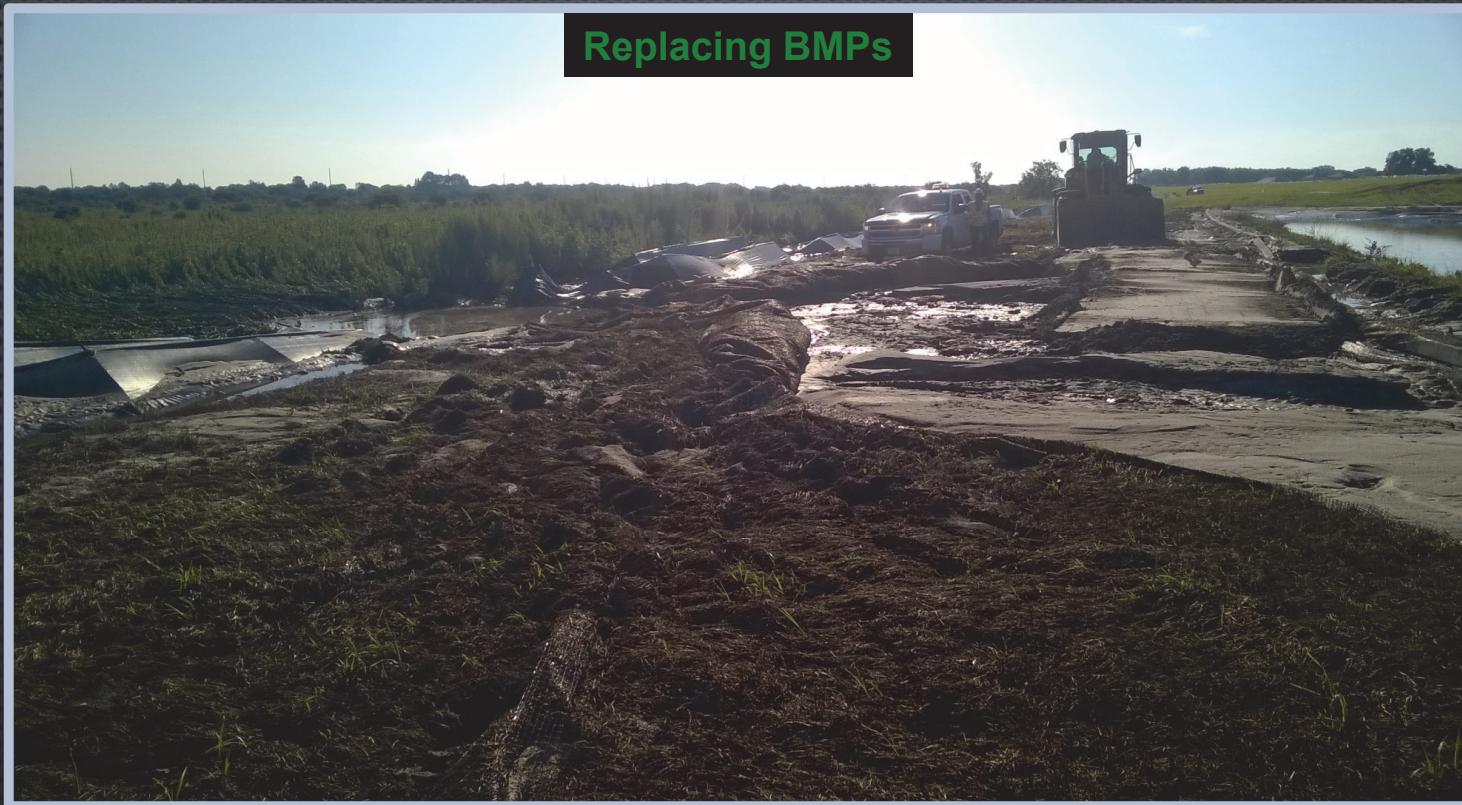
Wetlands drain to the canal which flows on to the Ranch property for pump discharge to Lake.

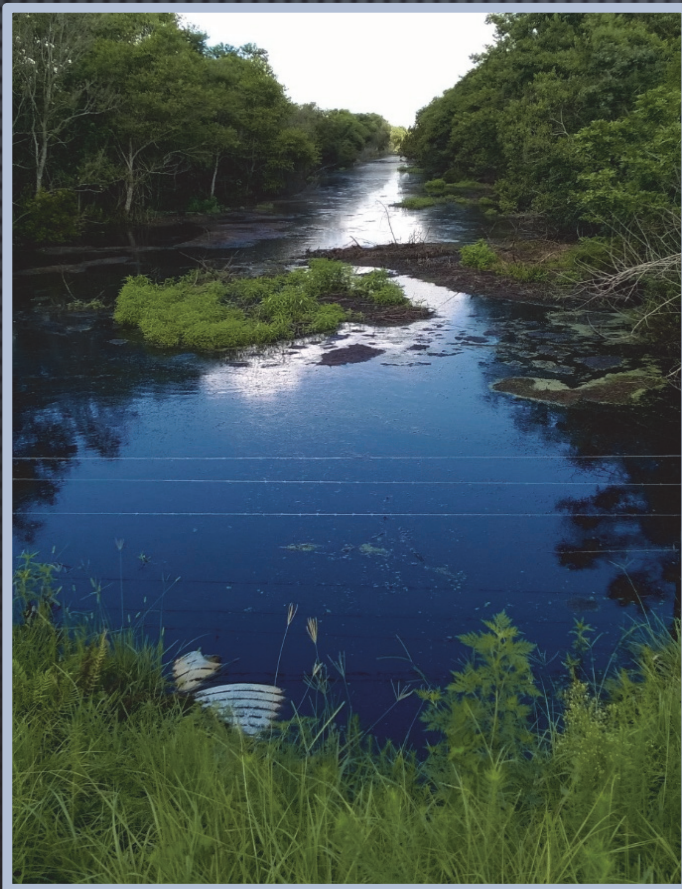
BEFORE

# CANAL

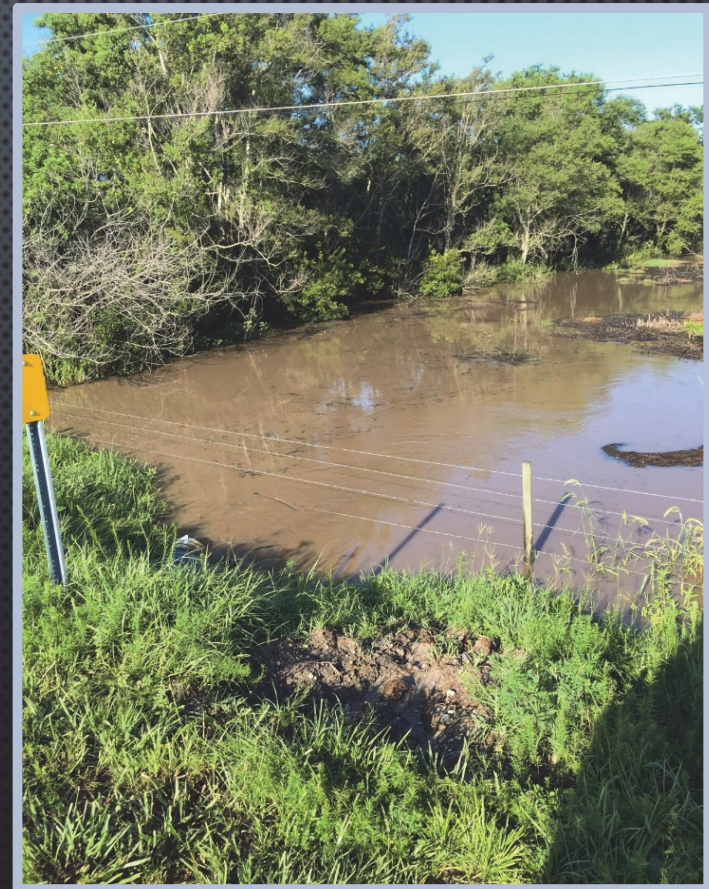
AFTER

SFWMD meeting on site 7/20/17, NTU's in wetland 506, ponds over 1K and canal 300-500 NTU. Background – 2-3 NTU

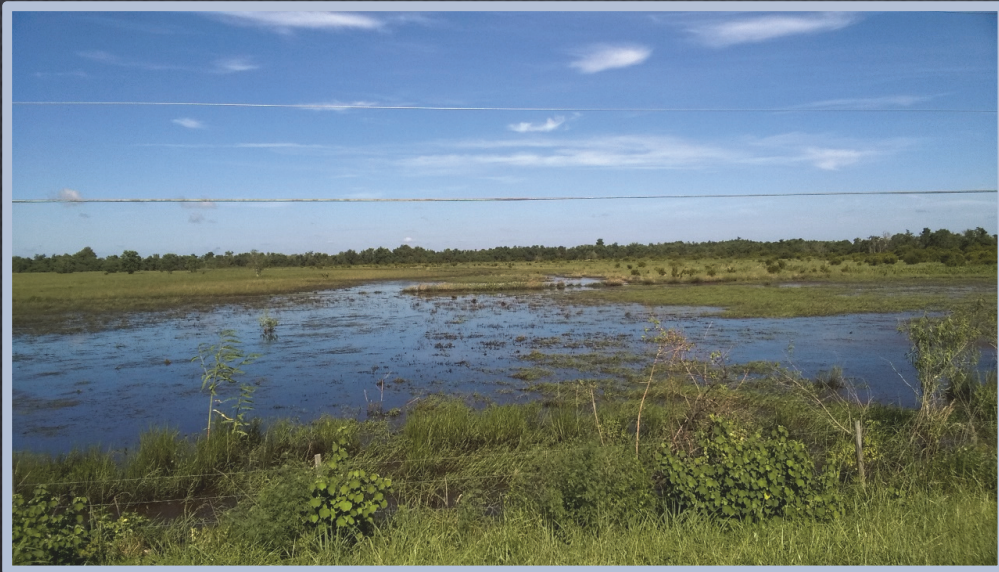
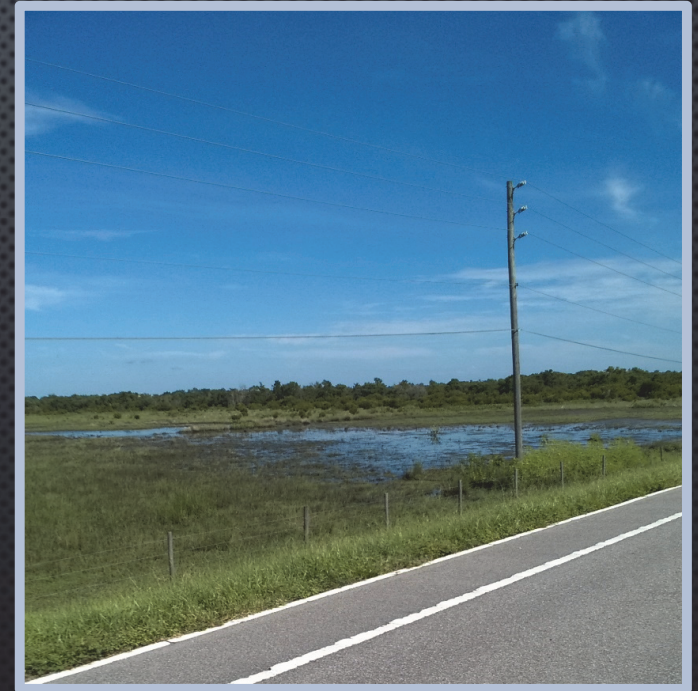
# Discharge point - Ranch land flooded
